Zlin Aviation S.R.O.

Safety Alert	No 09	20.08.2019
---------------------	--------------	-------------------

MANDATORY

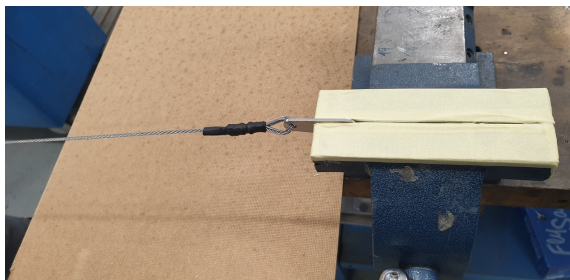
Hold the wire

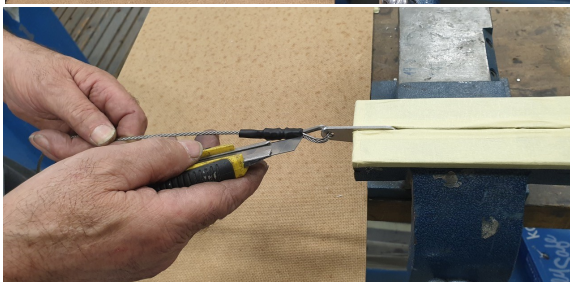
Cut the shrinkable tube

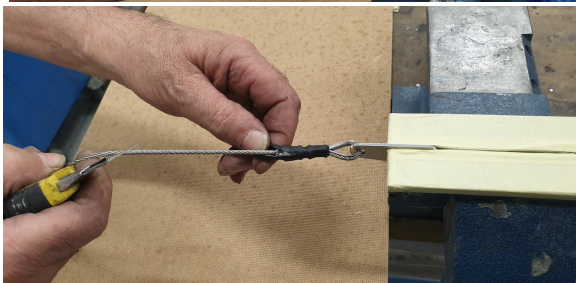
Remove the tube

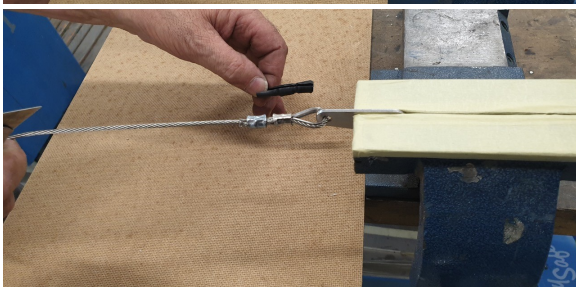
Inspect the sleeves
